**STRUCTURAL CONDITION SURVEY
FOR THE
PROPOSED CONVERSION OF BARN
TO FORM 3 NO DWELLINGS
AT GREENGATES FARM
GISBURN
CLITHEROE
FOR MR & MRS A ROBINSON**

Date: 3rd Aug 2020
Our job ref : 4402
Author: LYNNE RUSHWORTH

SUNDERLAND PEACOCK & ASSOCIATES LTD.
HAZE NERE, PINNICO ROAD, CLITHEROE,
LANCASHIRE BB7 2AG
T 01200 423178 F 01200 427328
E info@sunderlandpeacock.com
www.sunderlandpeacock.com

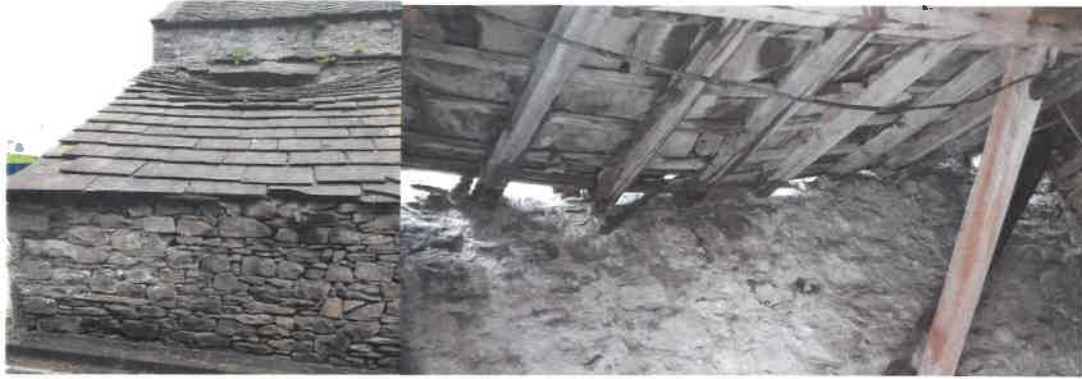
The rafters to the lean- to on the North elevation towards the north east edge have rotted at the abutment with the wall leading to sagging these timbers will need to be replaced and the grey slates be reinstated. See photo 1, below

Photograph 1- Roof deterioration on the north lean -to.

The Barn has suffered minimal deterioration since the 2017 report, with the exception of the lean to roof which requires new rafters.

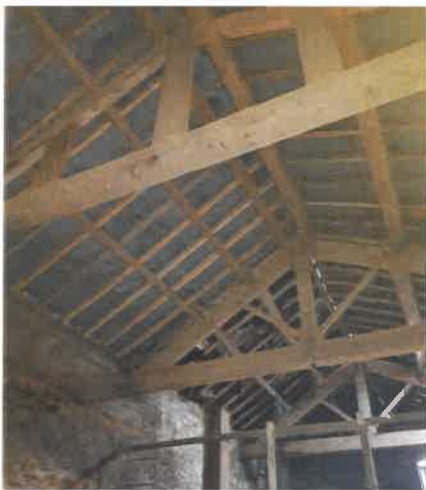
The roof to the main barn has been kept in a reasonable state of repair, as a result the roof timbers are also in good condition (see photograph 2).

Photograph (2) – showing the good condition of the trusses purlins and rafters in the main barn.

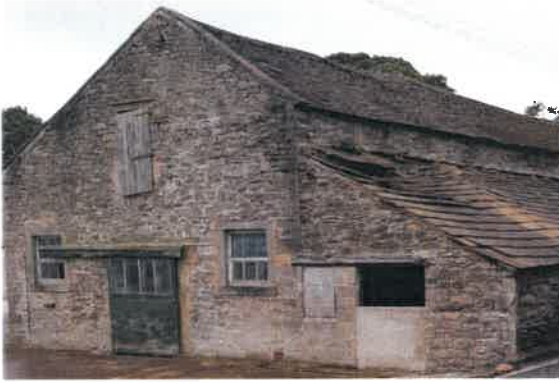
The 2no window openings to the east elevation have been formed with dressed stone surrounds. The forking hole has a stone head and the sliding door openings which are more recent additions have concrete lintels over. All the stone surrounds are in good condition and will be retained. The concrete lintels will be replaced with stone to match existing. There is also a triangular vent opening at the apex of the gable formed in stone.

There are a few sections of the wall which require re-pointing, but the walls are generally in extremely good condition.

Photograph (3) – East elevation

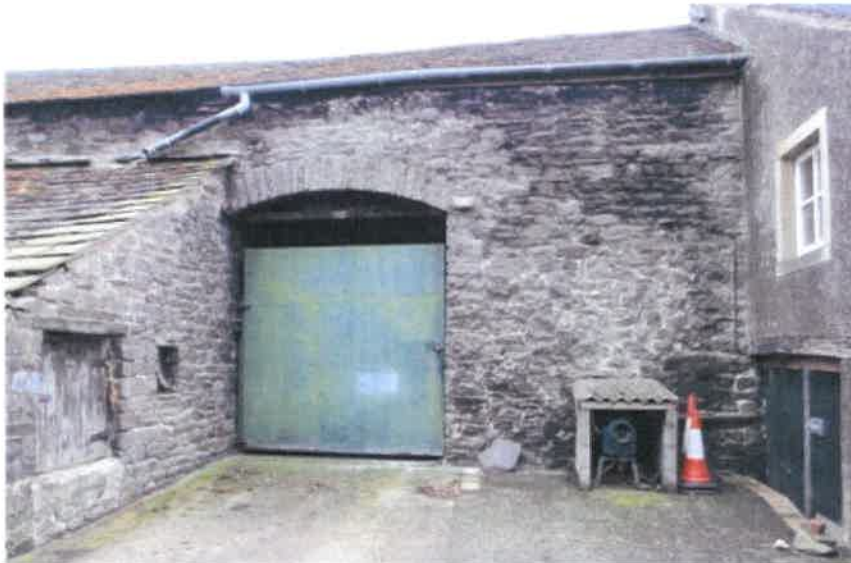
The return wall has a window opening with a slim stone head, it has been a door opening which has been built up with no sill. There is a further small window opening with a stone head. both the wall and the pointing are in good condition.

Photograph (5) Lean -to Return and cart opening

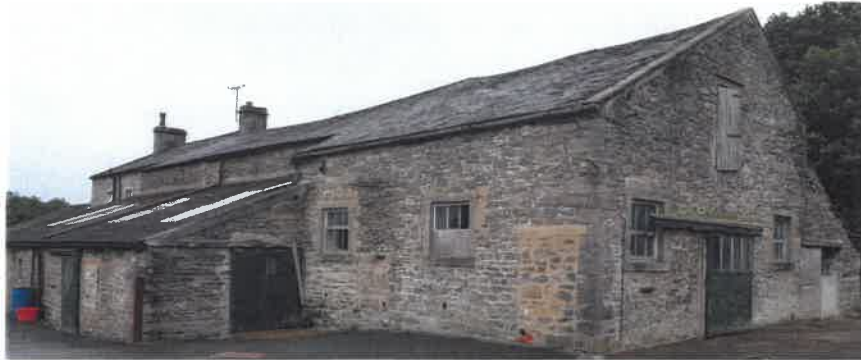
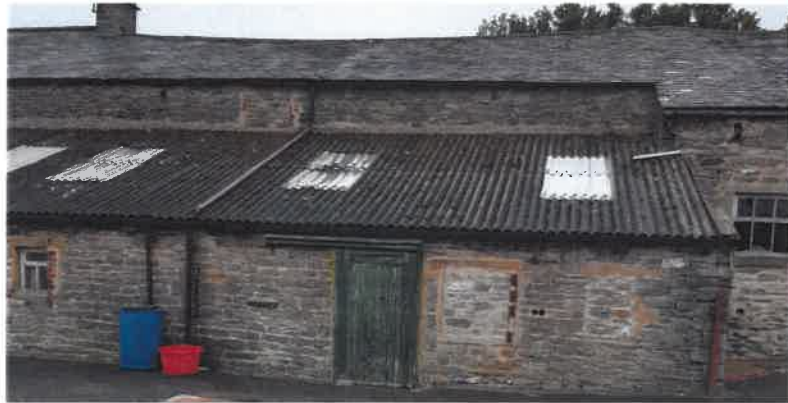
The door and window openings to the south elevation and returns have dressed stone surrounds, the lean-to having 2no openings which have been built up the 1no

remaining window opening has a brickwork jamb and a sand stone head and sill. The pointing on this elevation is in very good condition as is the stone work.

Photograph (6 & 7) – South elevation

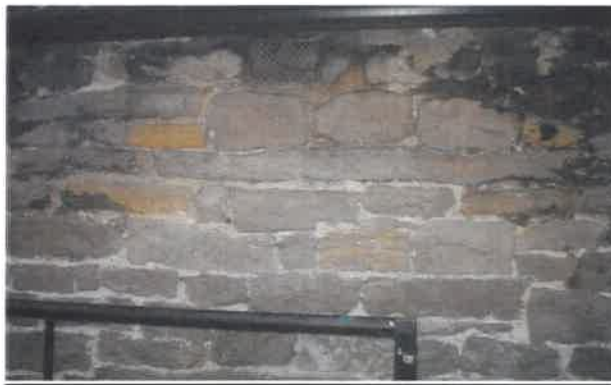
Photograph (8) – Stone detail on south elevation

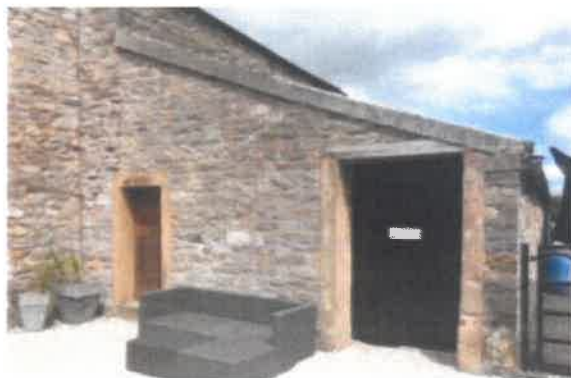
Photograph (9) – South lean –to return elevation

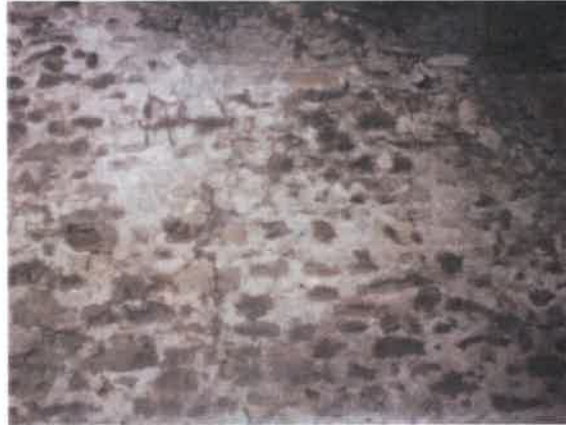
The internal walls of the barn are in good condition, this can be seen in the photograph below.

Photography (10) – Internal wall
